# SAMPLE REPORT

## Inspection Report

**MTA Vehicle Inspections (ABN 82625589513)**

TOYOTA LANDCRUISER TROOPY

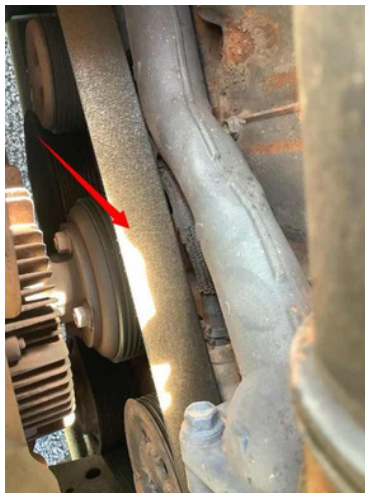
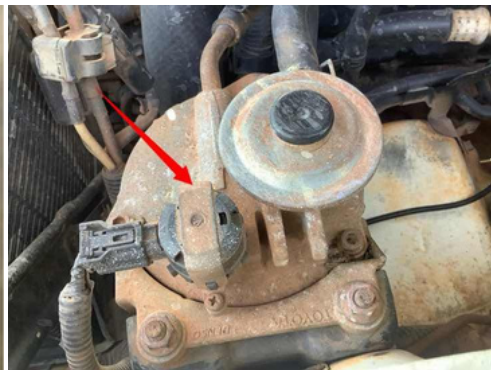
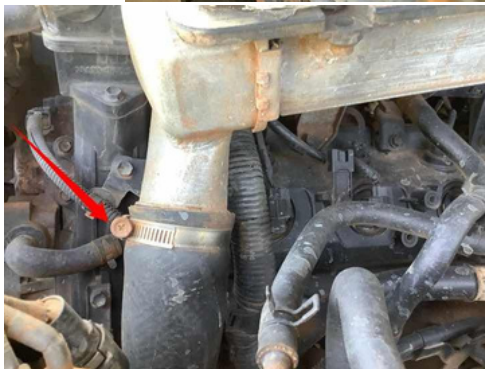
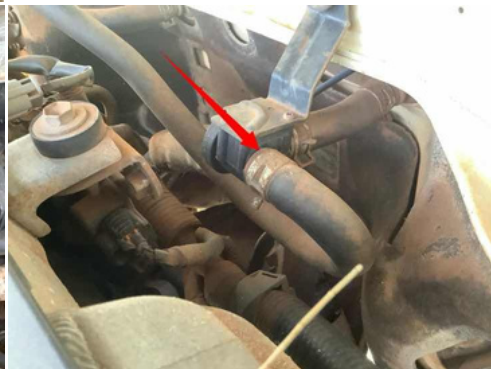
### Engine bay

Surface rust / oxidation on various engine bay components.

External drive belt has fatigue cracks-suggest replacement.

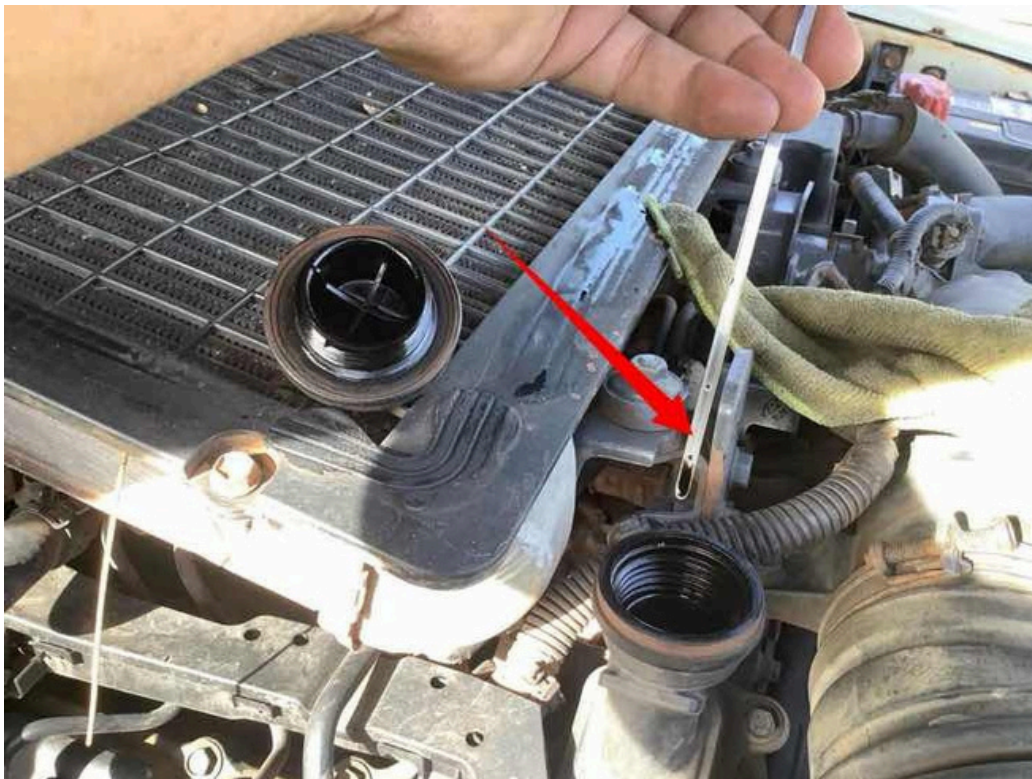
## Oil and lubrication

Oil level low-suggest top up to acceptable level/ service.

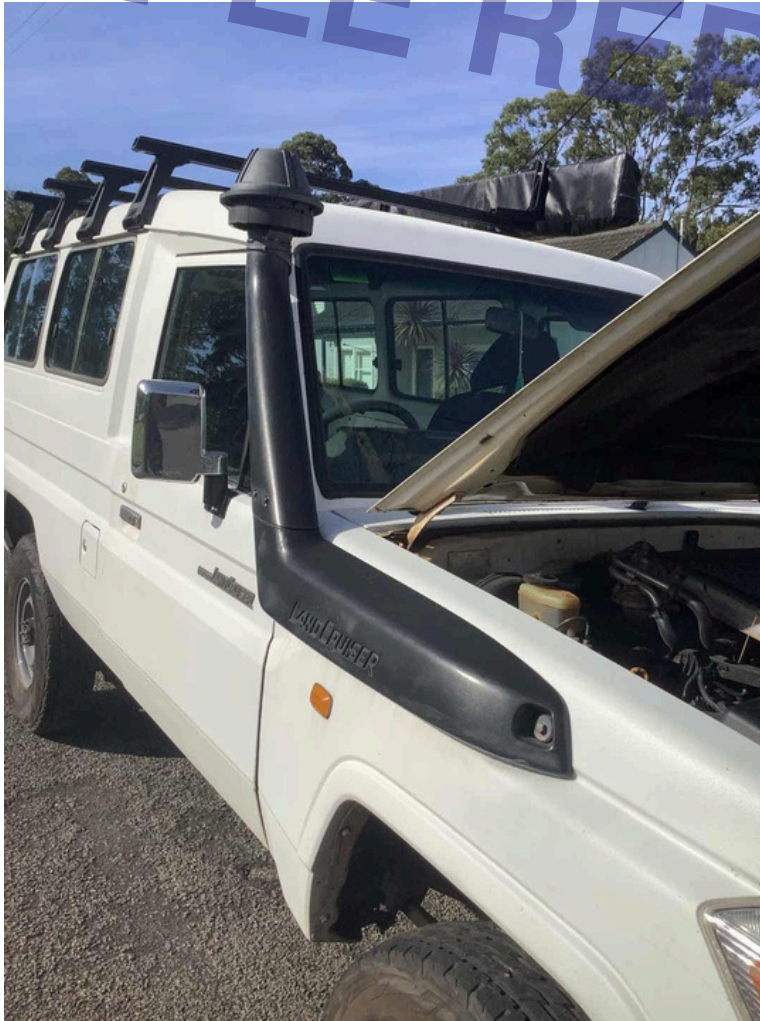
### **Air filter assembly**

Air filter has been modified.

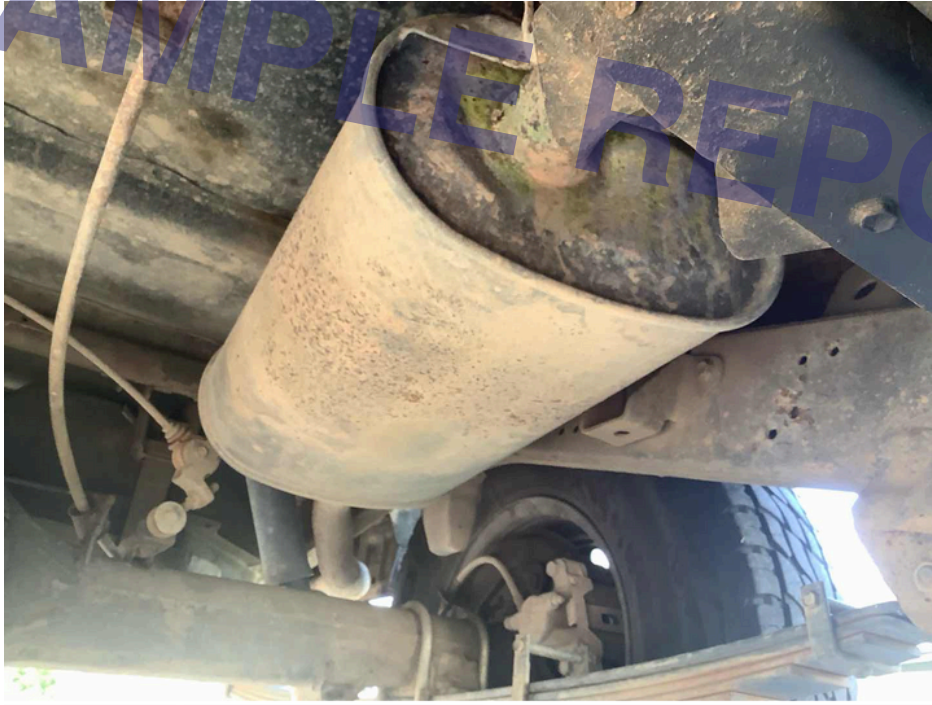
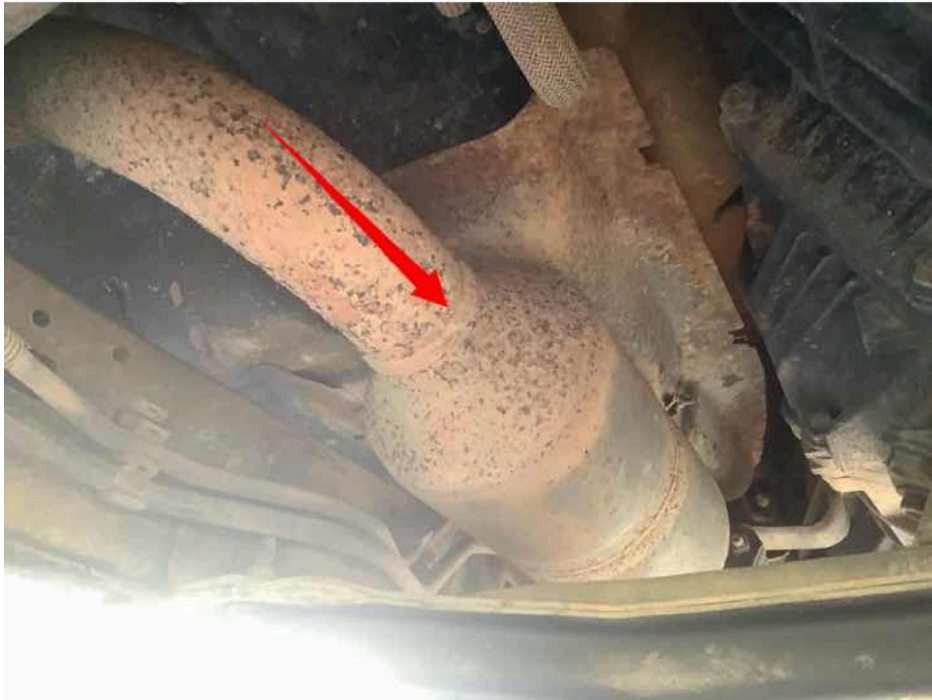
## Exhaust Comments

Muffler is rusty-monitor/replace.

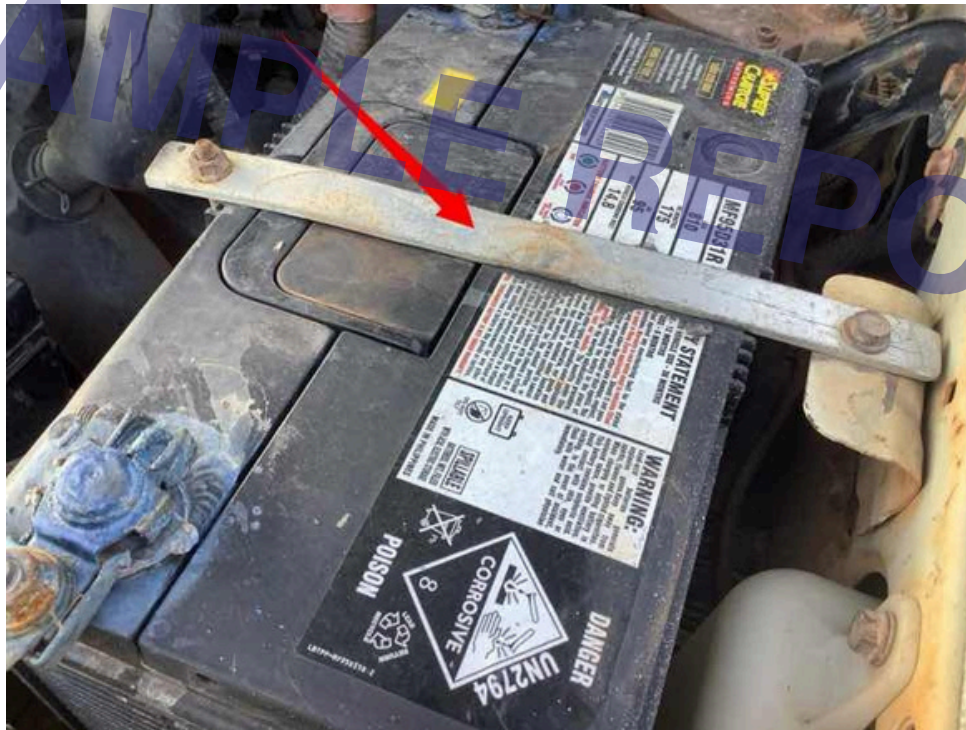
## Battery

Battery not secure-repair as required.

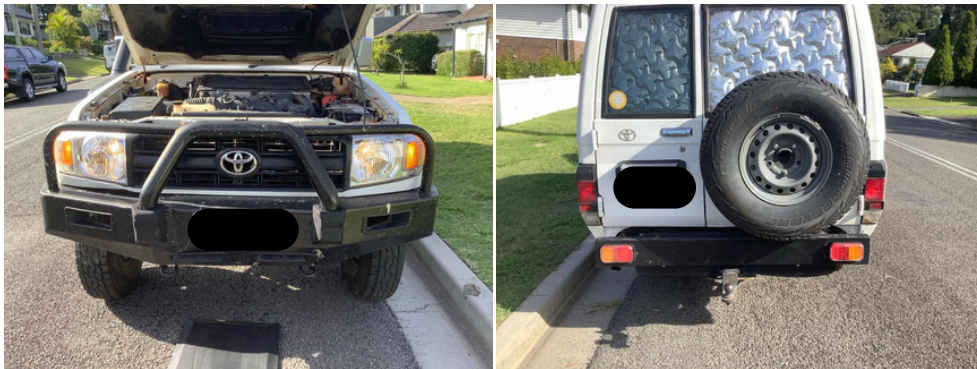
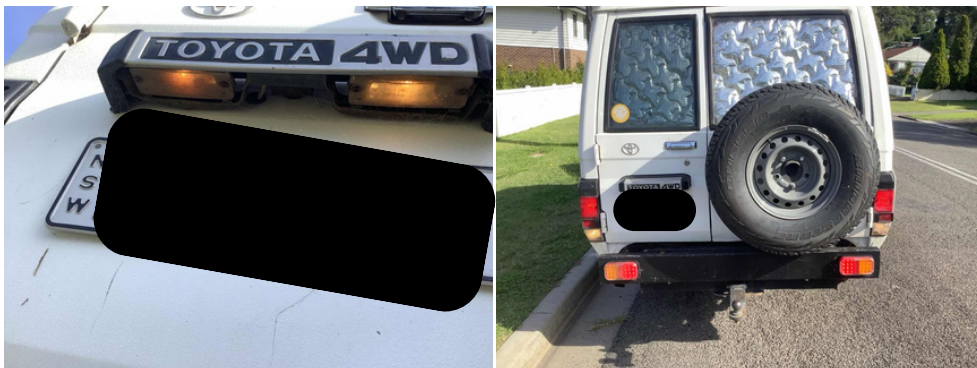
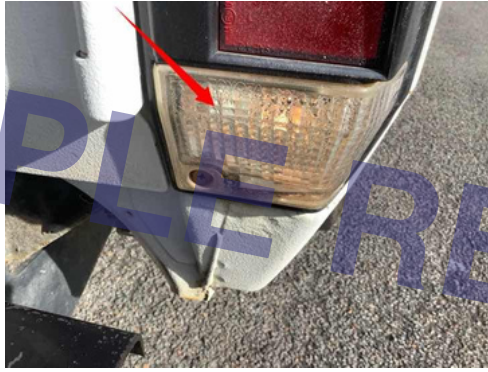
## Lights and lenses

Condensation in lens-repair as required.

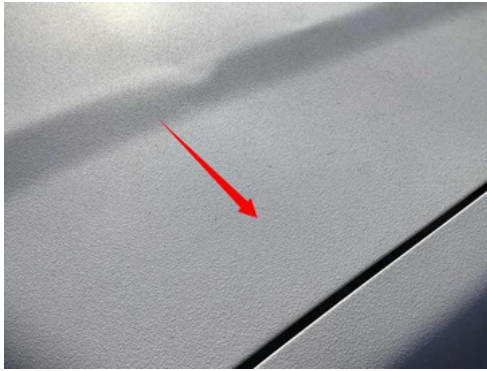
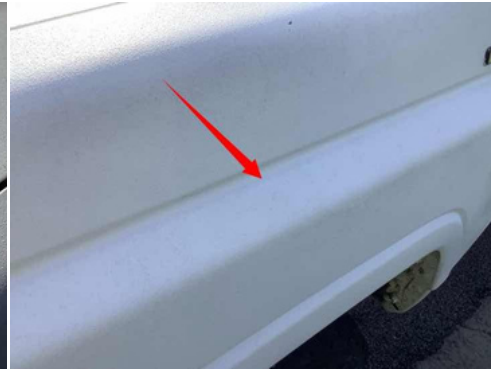
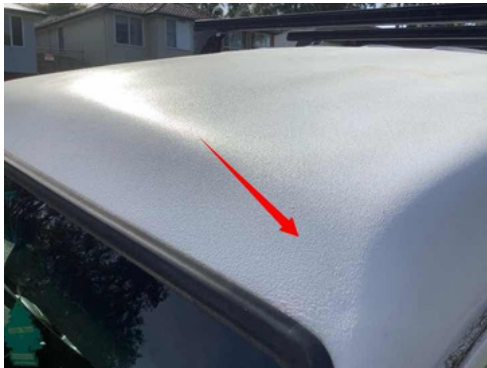
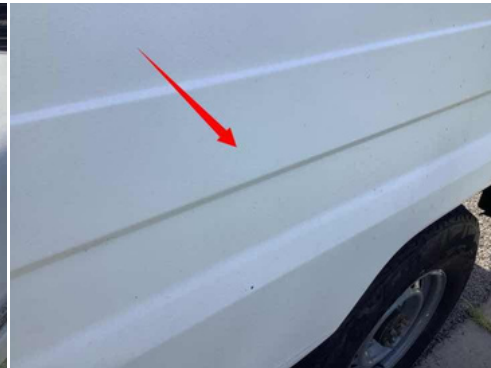
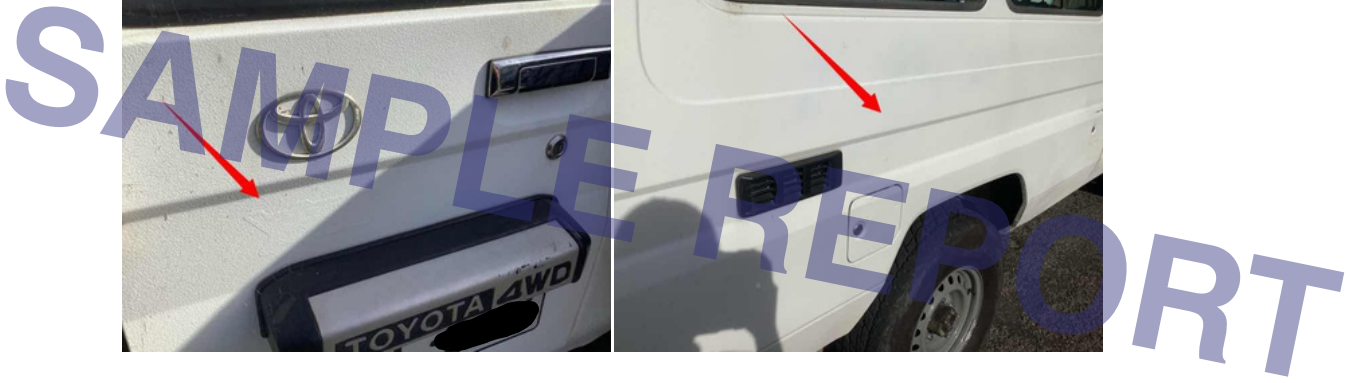
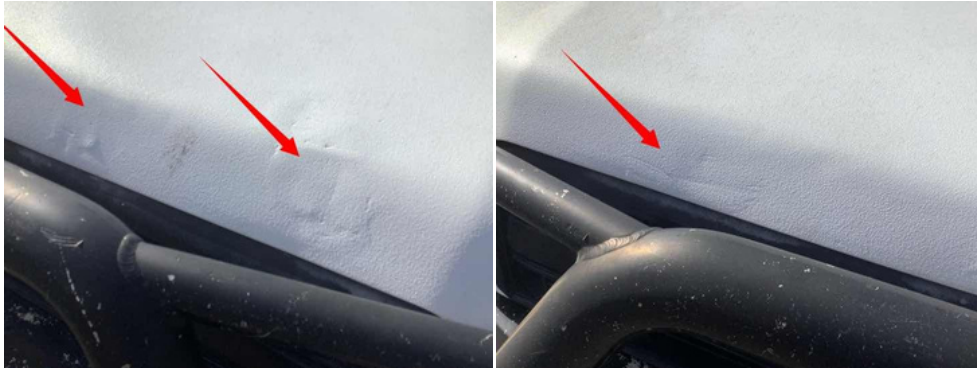
### Panel and paint repairs

Vehicle has had repairs which are not of a tradesman like standard, paint finish is poor and further repairs will be necessary to rectify, suggest further inspection by panel shop to determine overall cost of repairs.

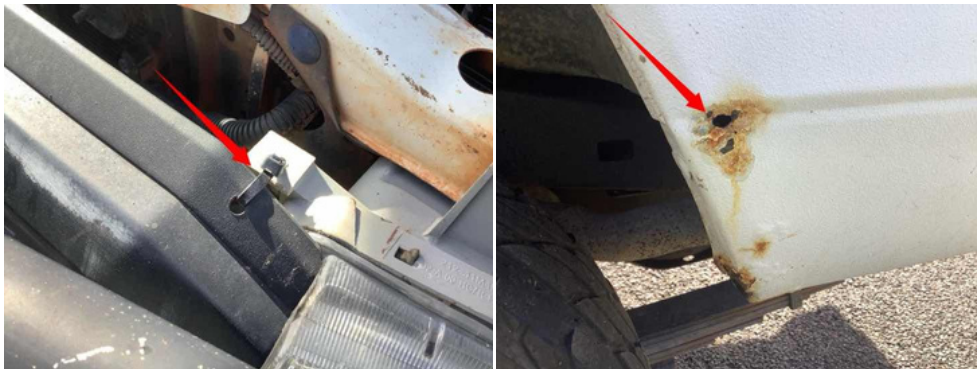
### External appearance

Dents, chips, scratches and marks to various panels and bumpers

Rust in various locations some more advanced will require further assessment and repair as required.

Front grill is not secured properly recommend check clips/mounts.

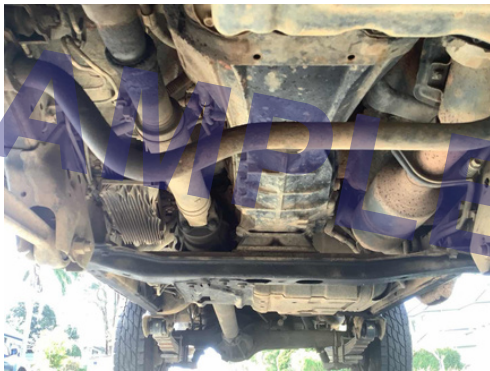
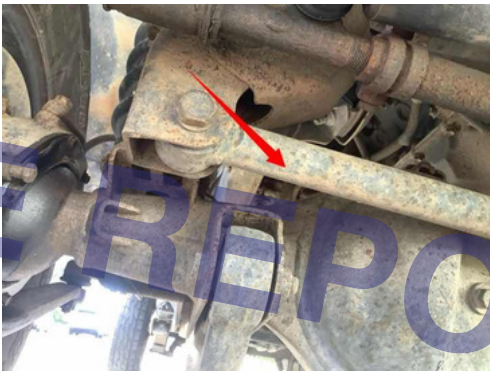
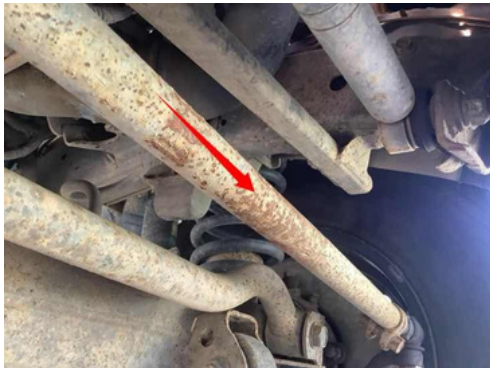
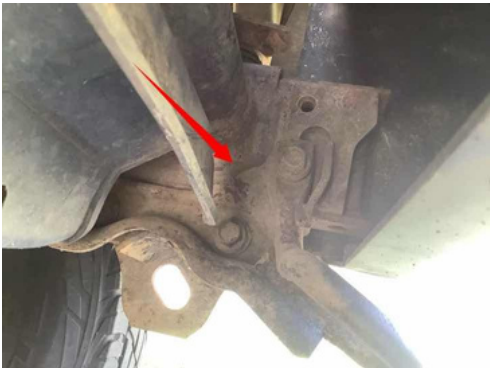
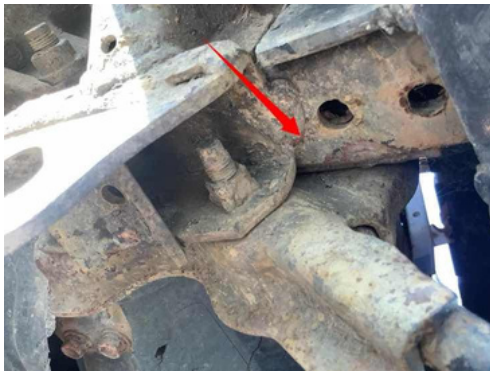
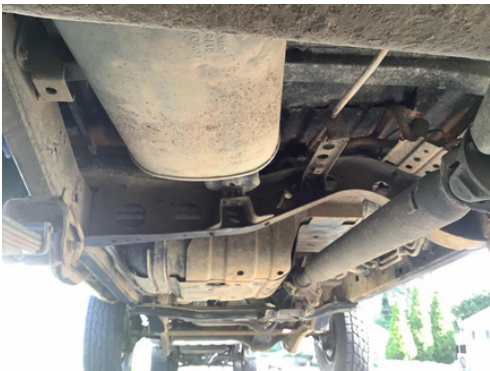
### **Underbody.**

Advanced rust to underbody. Will require repairs by qualified body repairer.

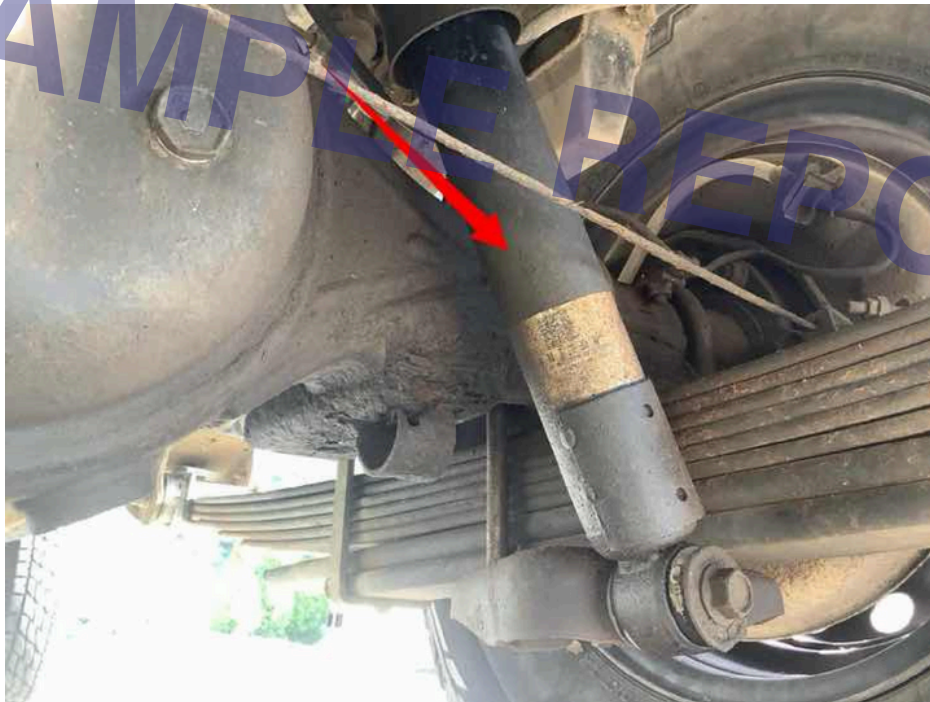
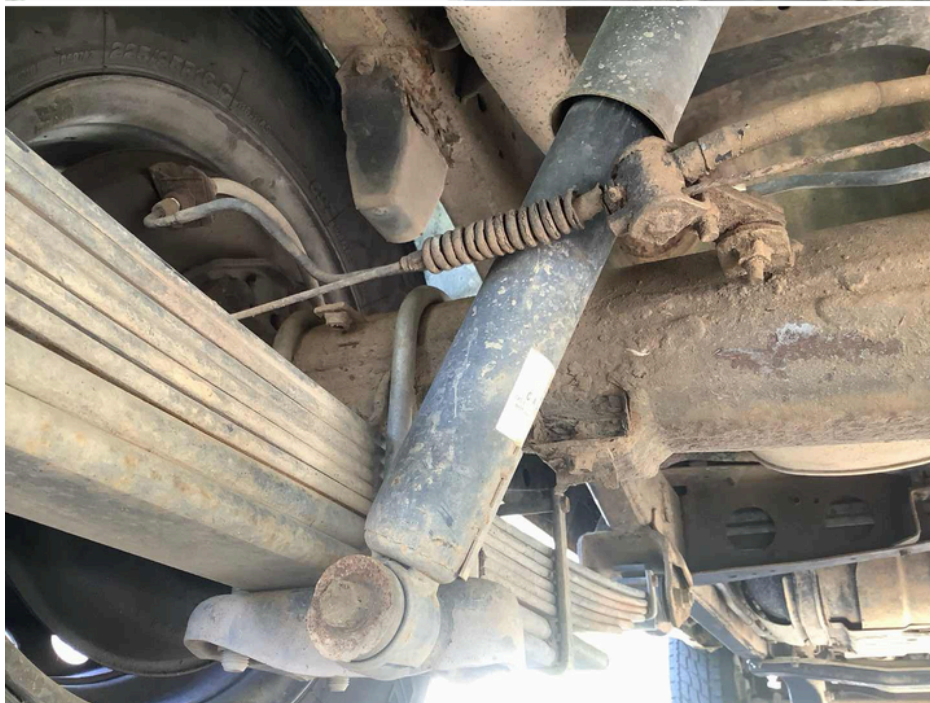
## Steering and suspension recommendations

Shock absorber is leaking, replace as required.

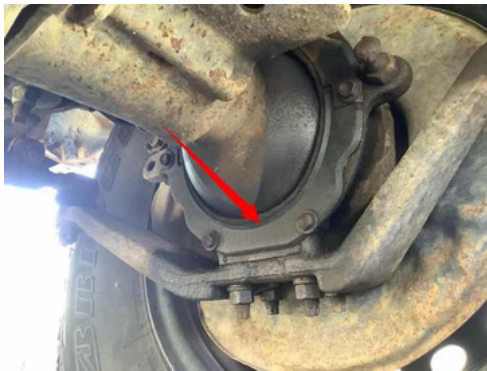
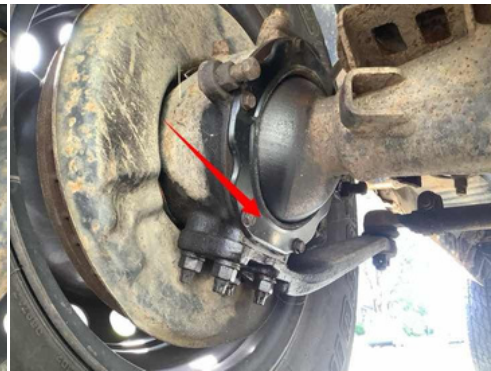
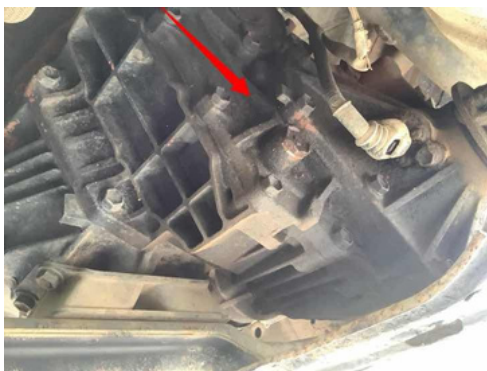
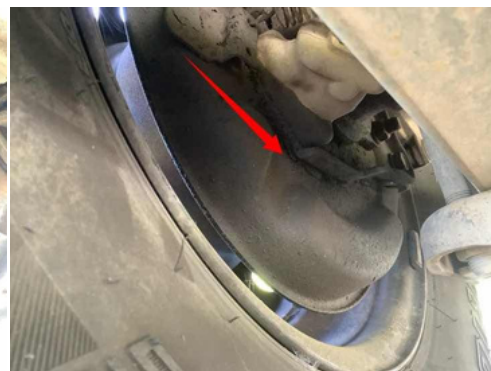
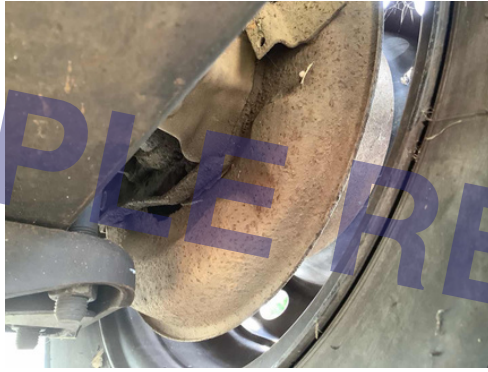
## Transmission/Gearbox and driveline comments

Transfer case oil see page/leak service/repair as required.

Rear axle seal leaking-requires further investigation including checking for brake friction material for contamination and repairs as required.

Front swivel hubs leaking-repair as required.

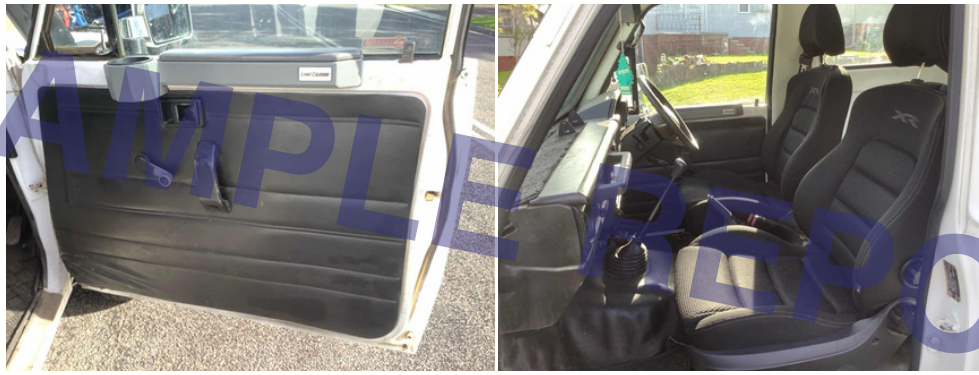
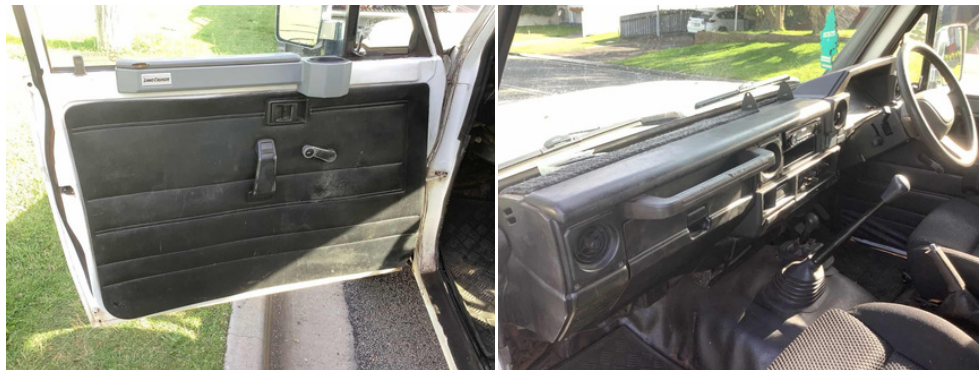
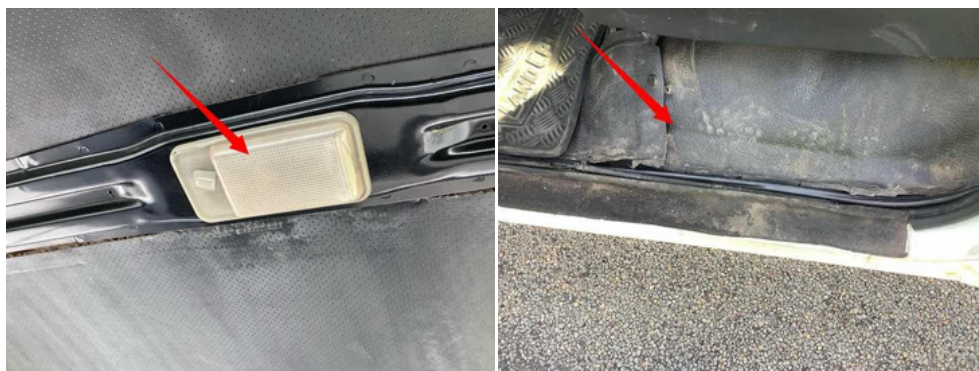
### Interior comments

Drivers front carpet showing wear.  
 Roof lining is damaged / sagged.  
 Wiper arm missing  
 Window washers missing  
 rust at seat frame and under dash.  
 Interior lights inoperative-repair as required.  
 Interior needs repairs

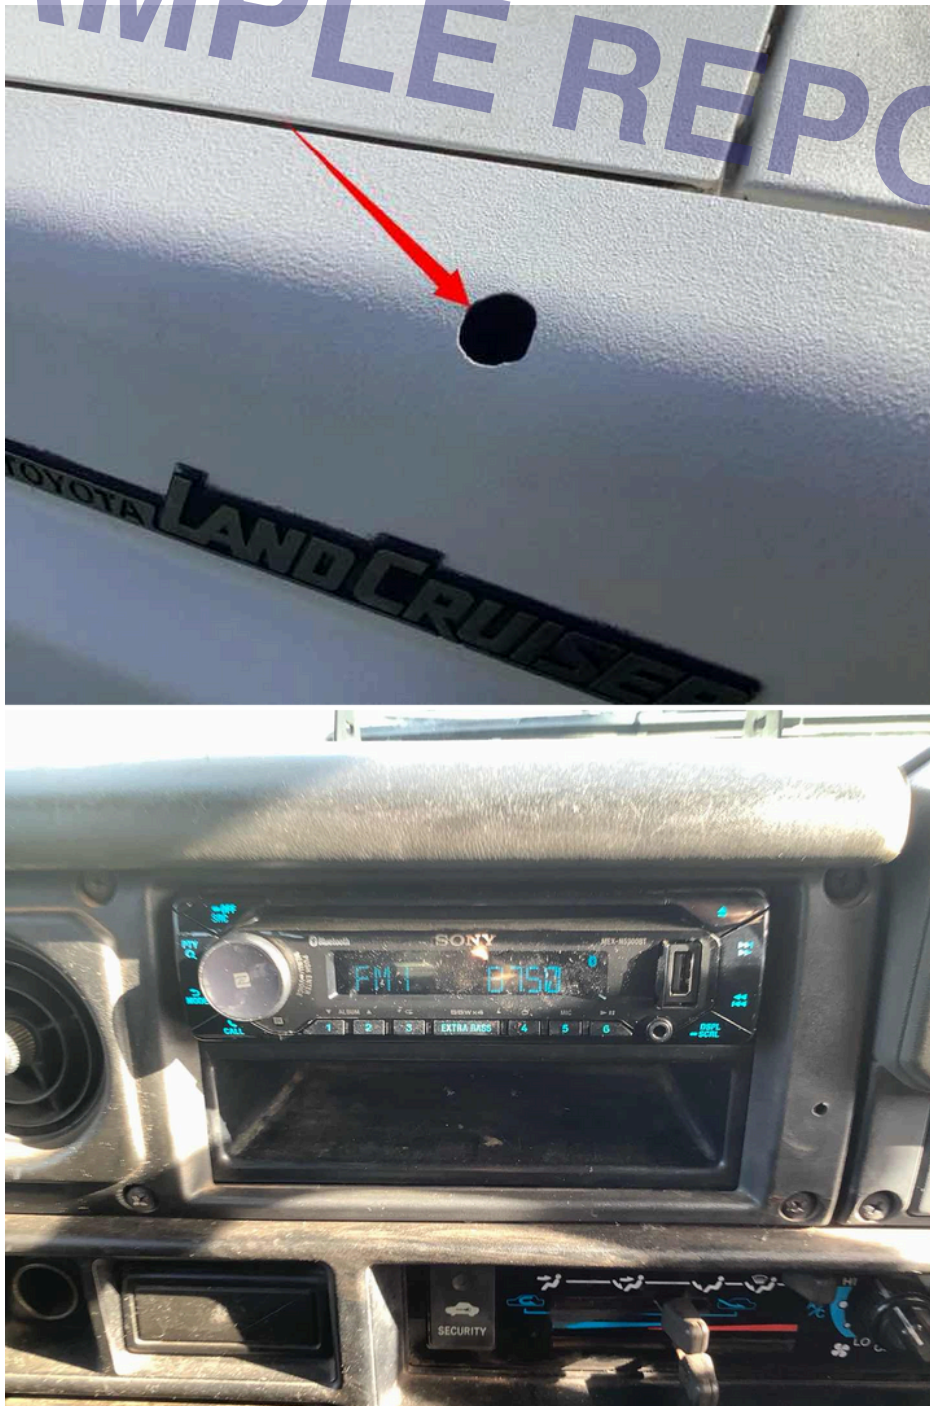
**Entertainment.**

Aftermarket stereo fitted.

Antenna broken needs replacing for optimal reception.

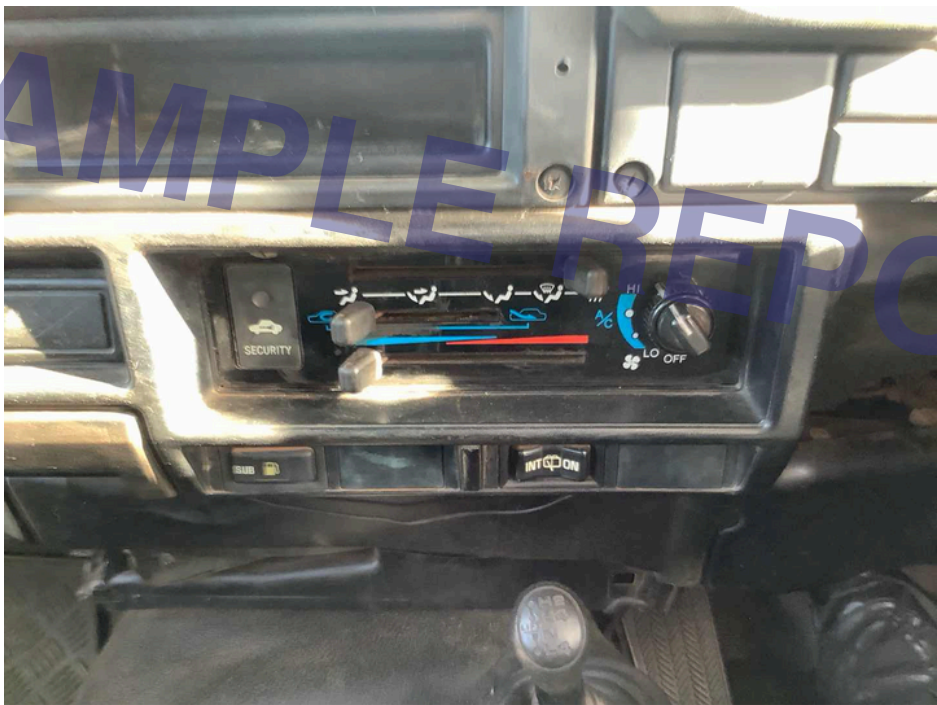
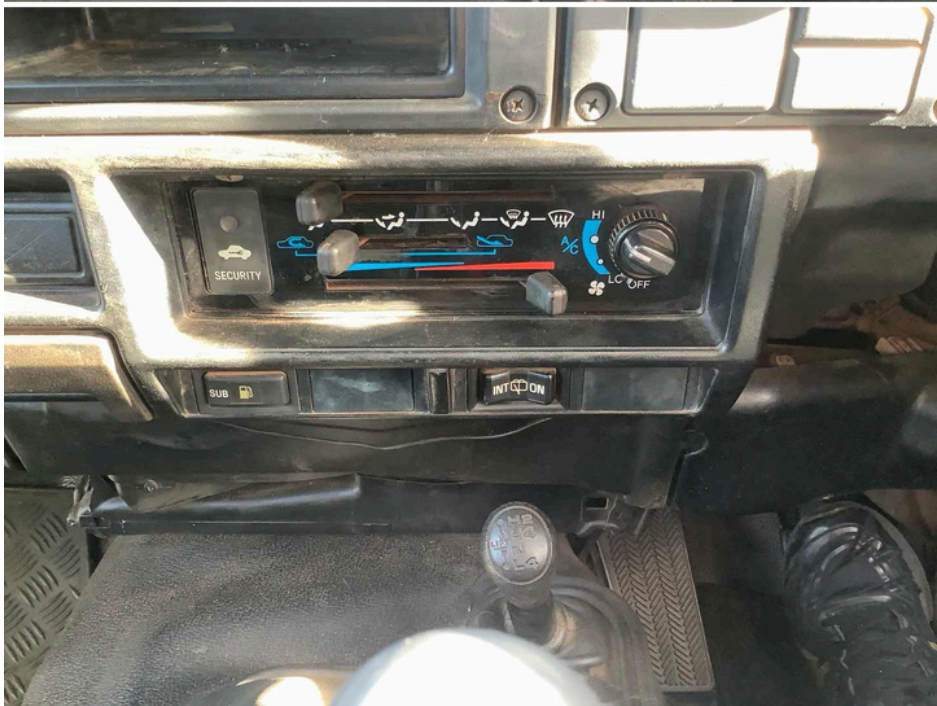
**Air conditioning**

Air conditioner not getting cold-requires further investigation and repair as required

Heater not heating as expected-requires further investigation and repair.
