# SAMPLE REPORT

## Inspection Report

**MTA Vehicle Inspections (ABN 82625589513)**

TOYOTA LANDCRUISER TROOPY

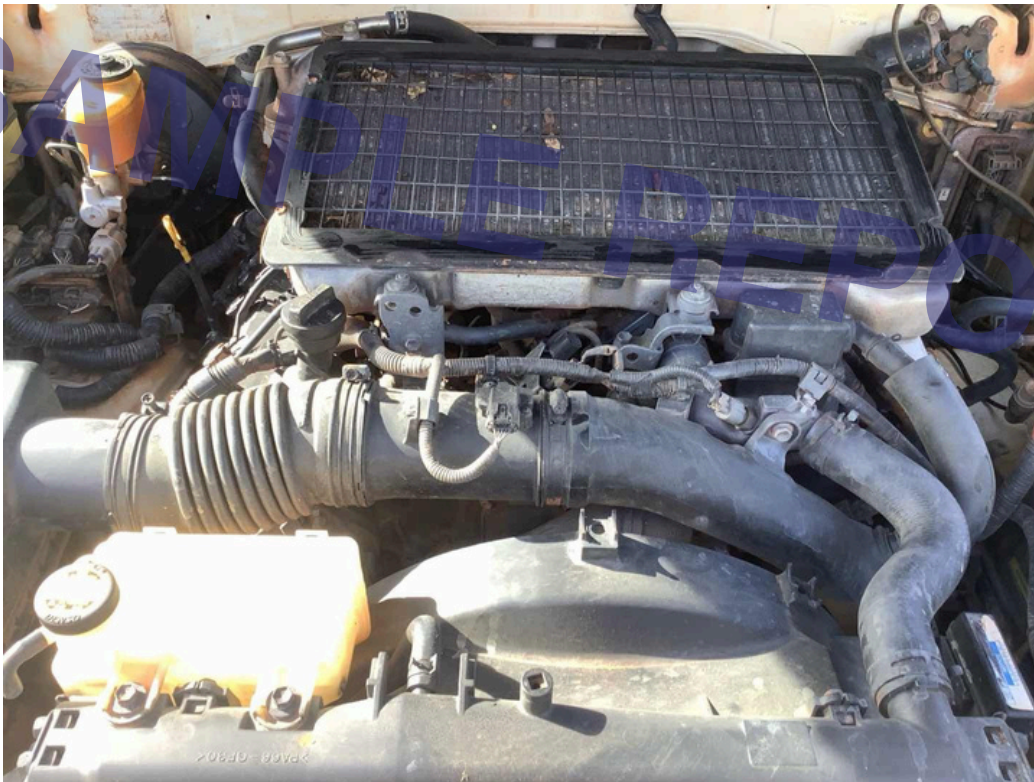
### Engine bay

Surface rust / oxidation on various engine bay components.

External drive belt has fatigue cracks-suggest replacement.

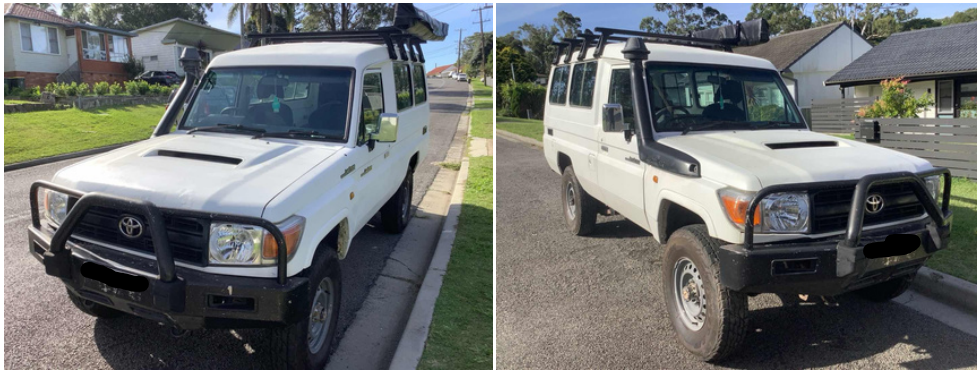
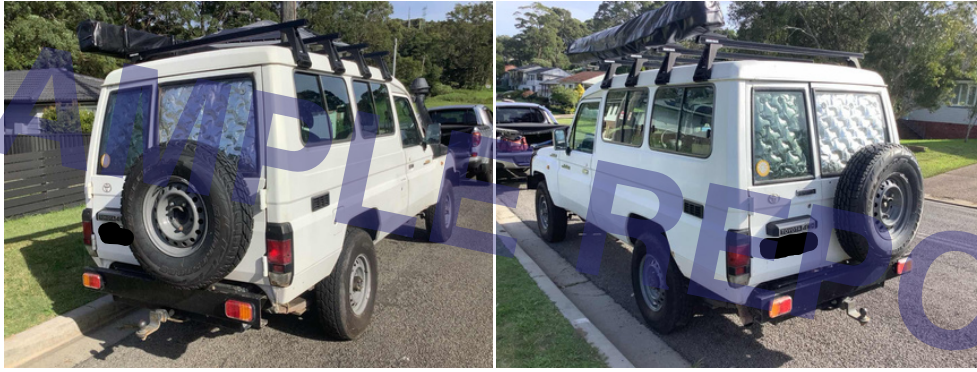
### Panel and paint repairs

Vehicle has had repairs which are not of a tradesman like standard, paint finish is poor and further repairs will be necessary to rectify, suggest further inspection by panel shop to determine overall cost of repairs.

Rust in various locations some more advanced will require further assessment and repair as required.

Front grill is not secured properly recommend check clips/mounts.

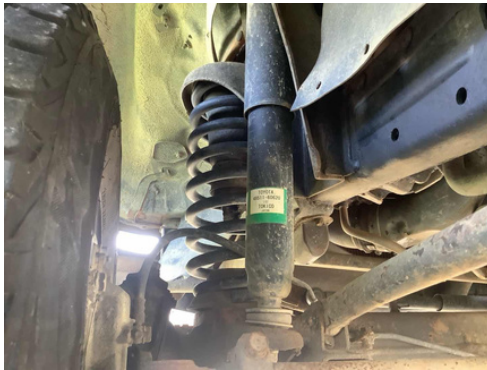
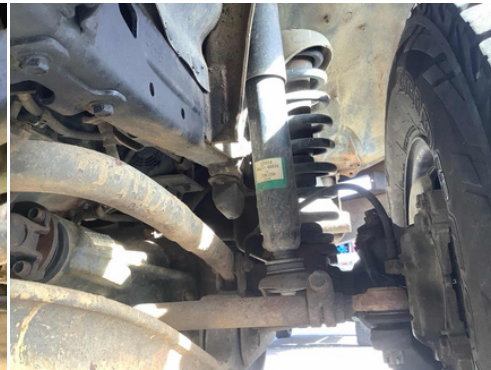
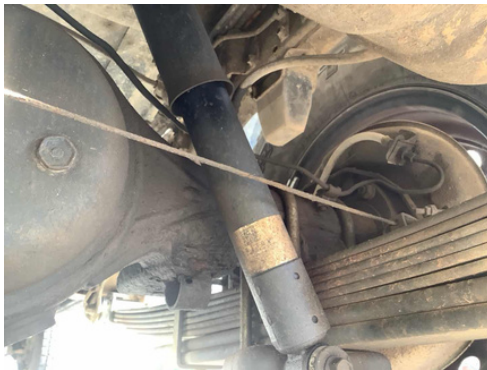
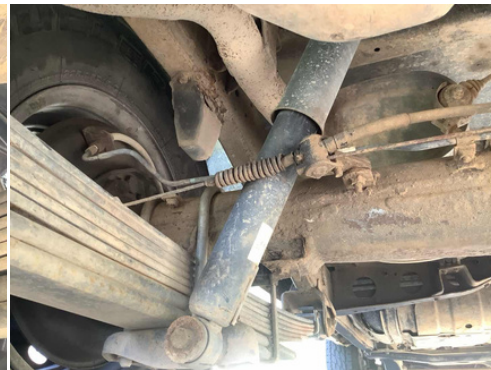
## Steering and suspension recommendations

Shock absorber is leaking, replace as required.

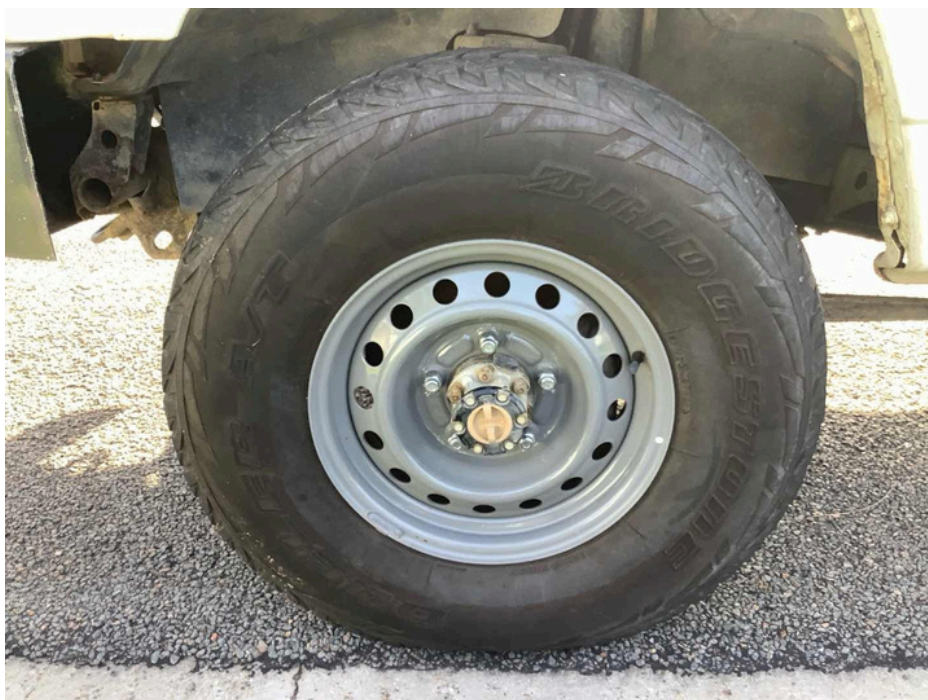
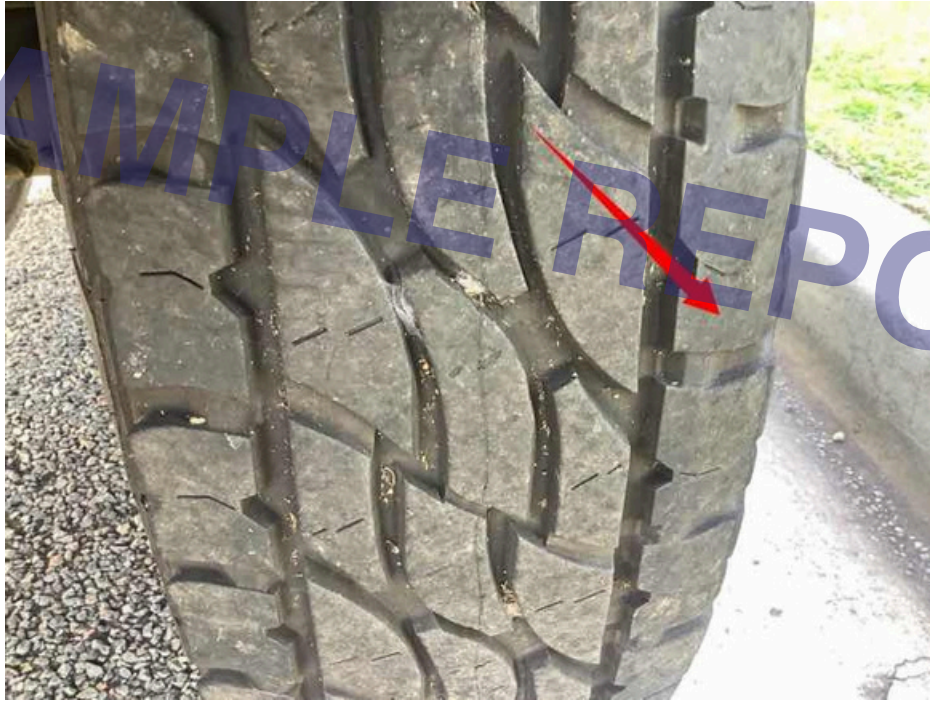
#### Passenger front

Tyres showing greater shoulder wear and will need replacing as listed recommend check wheel alignment when fitting new tyres.

Approximately 60% remaining.

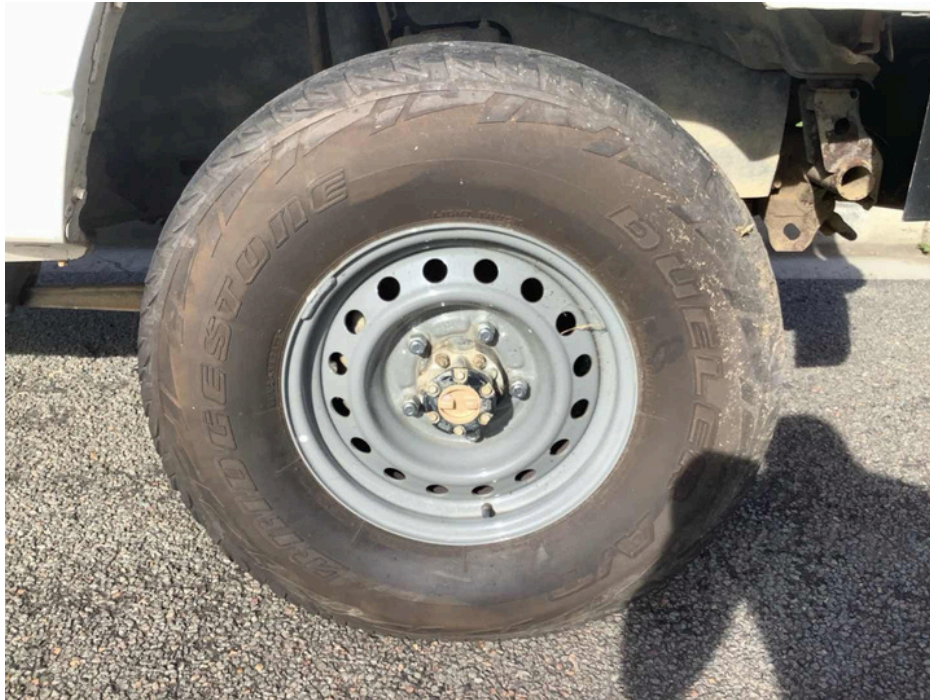
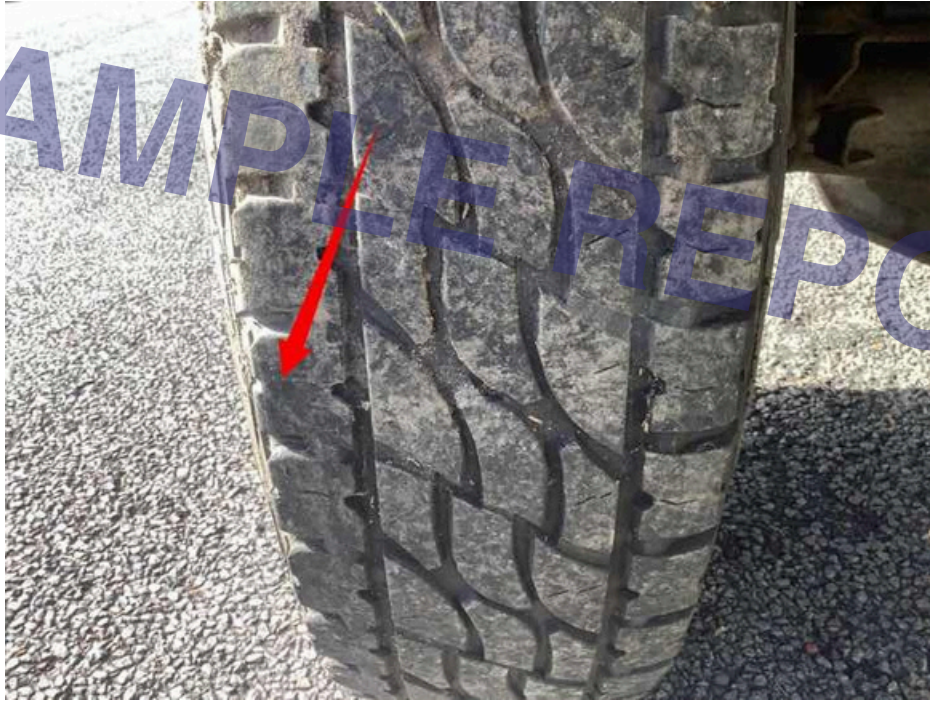
**Drivers front**

Approximately 60% remaining.

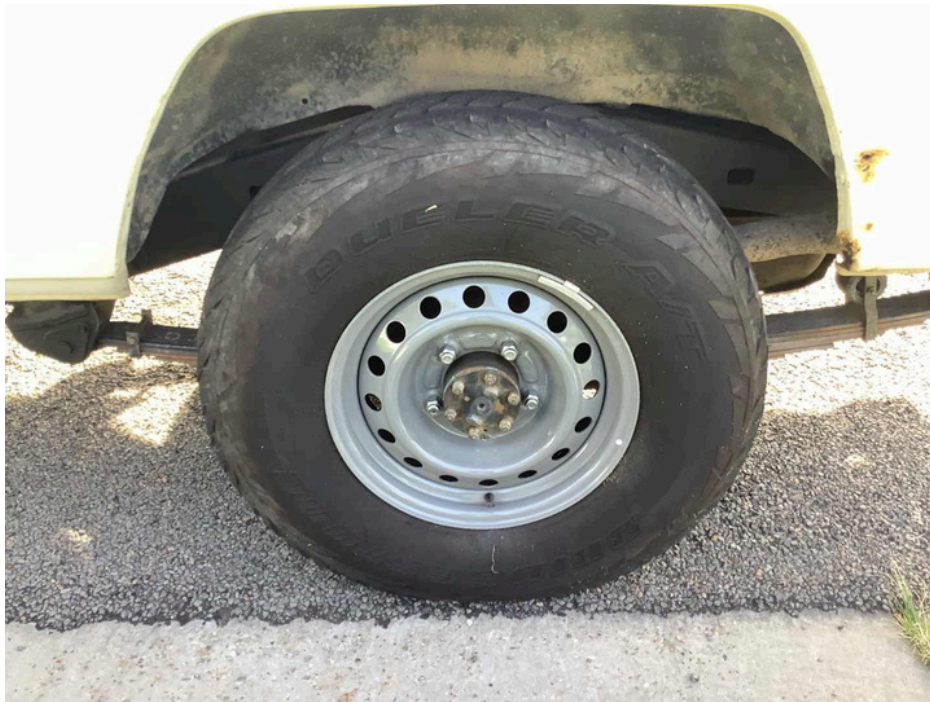
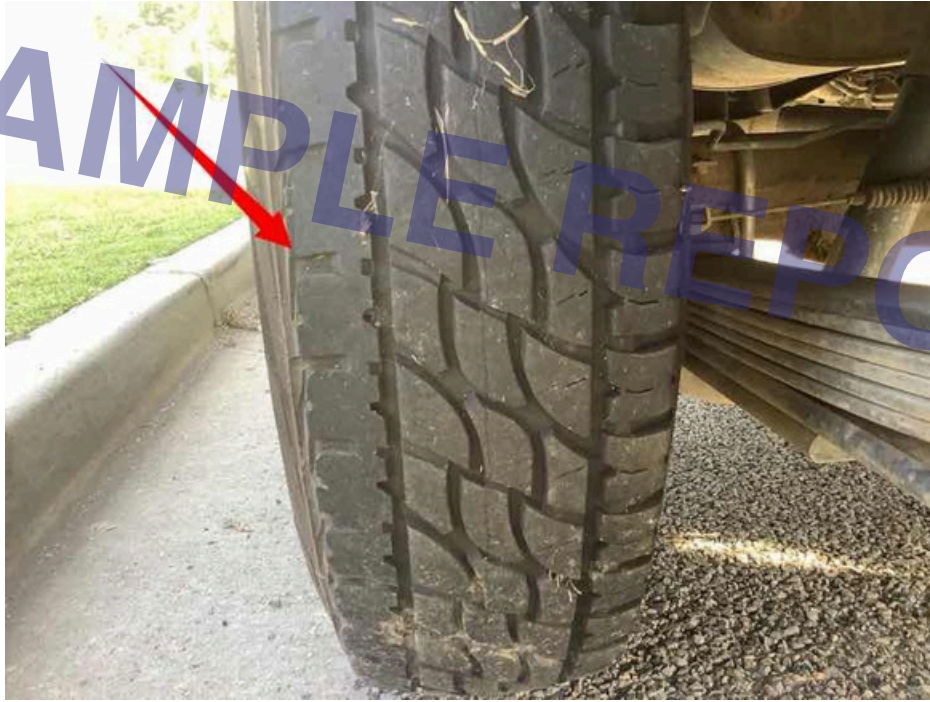
**Passanger rear**

Approximately 40% remaining.

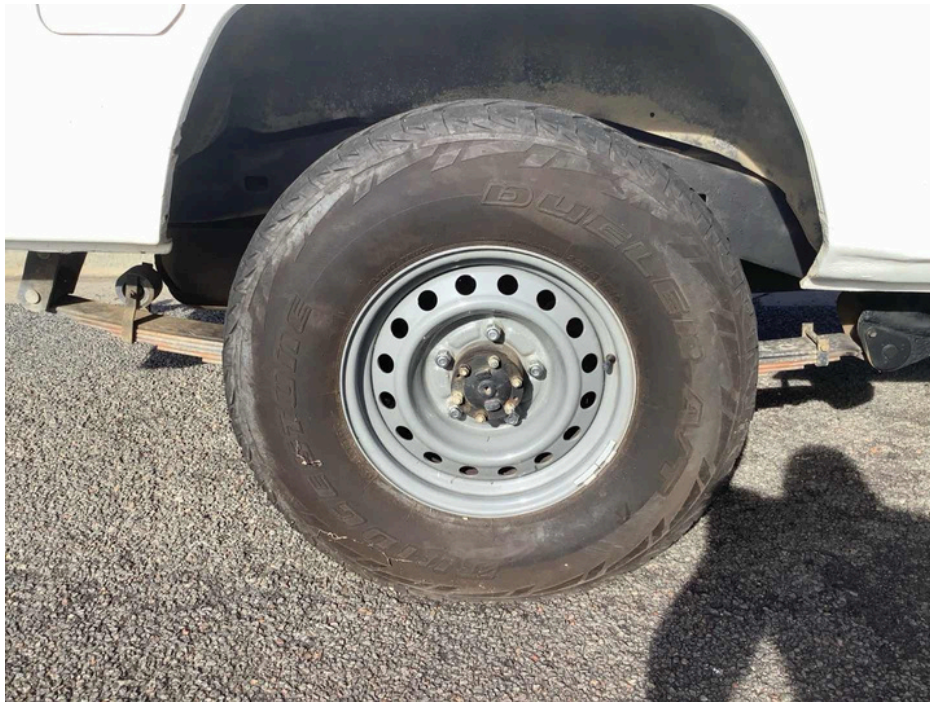
**Drivers rear**

Approximately 60% remaining.

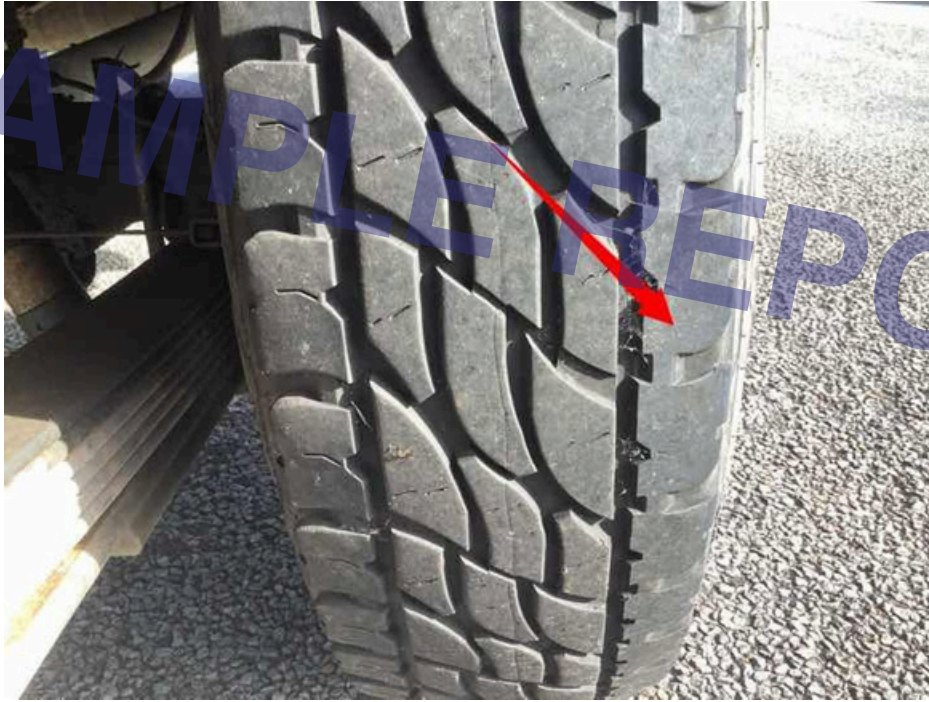
**Spare**

Approximately 100% remaining.

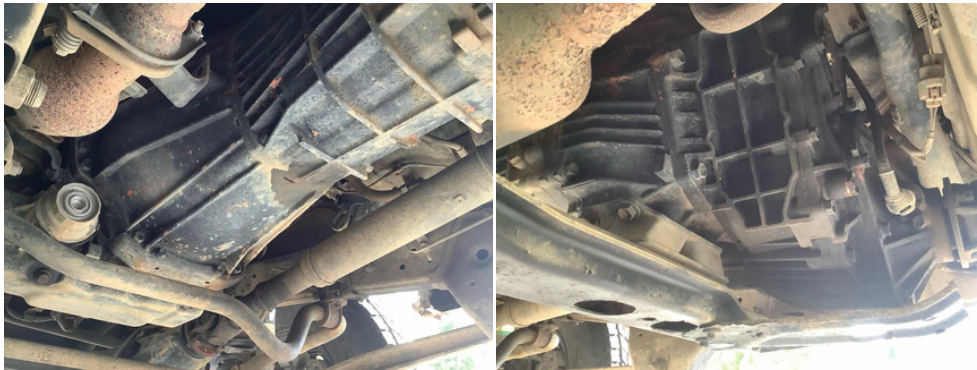
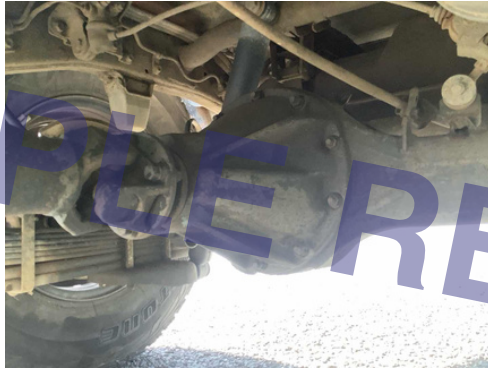
Transfer case oil see page/leak service/repair as required.

Rear axle seal leaking-requires further investigation including checking for brake friction material for contamination and repairs as required.

Front swivel hubs leaking-repair as required.

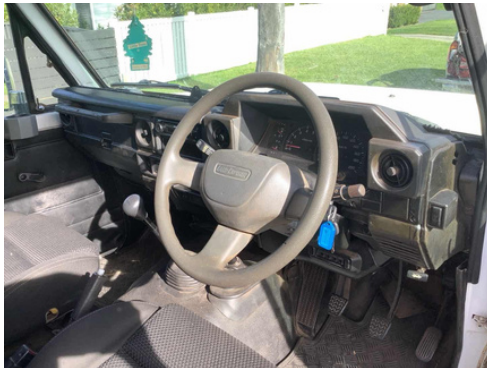
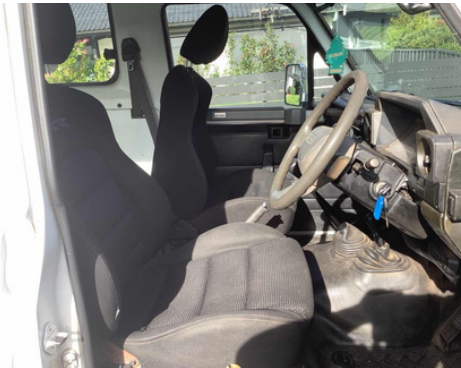
Drivers front carpet showing wear.  
 Roof lining is damaged / sagged.  
 Wiper arm missing  
 Window washers missing  
 rust at seat frame and under dash.  
 Interior lights inoperative-repair as required.  
 Interior needs repairs

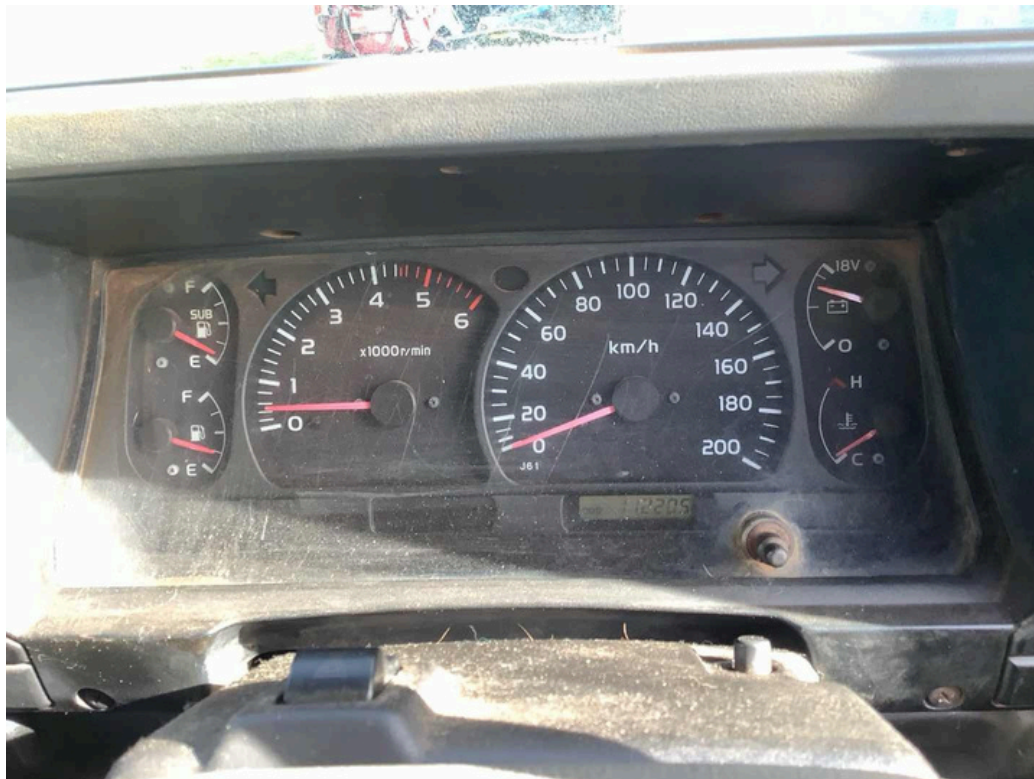
### Warning lights / Cluster

No warning lights illuminated at time of inspection.

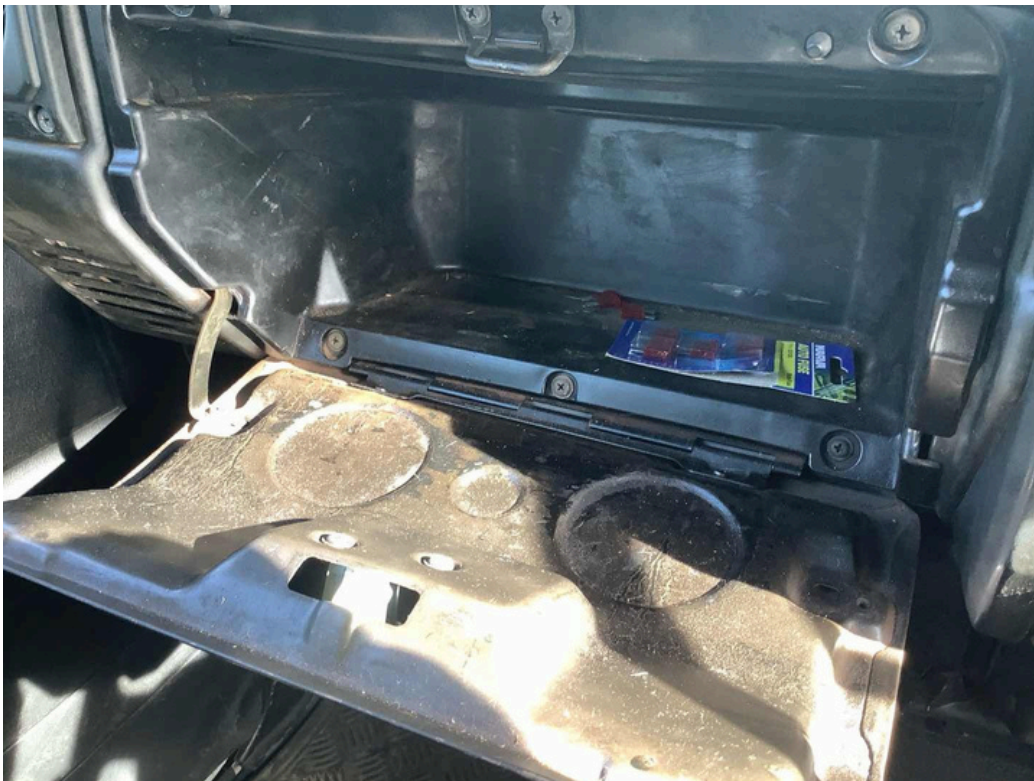
#### Service records

SERVICE LOGBOOKS WERE NOT AVAILABLE AT TIME OF INSPECTION.
